01 Cylinder head, oil sump

Programed Repairs Engines 601, 602, 603 Mechanical II

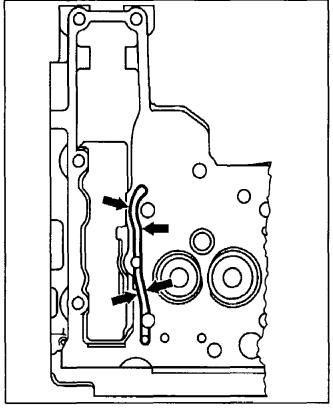
P01.30-0202-15

Cylinder head gasket leaking in area of oil cross gallery to cylinder 1.

- 1 Determine condition and inspect engine with inspection lamp, if necessary.
- 2 Replace cylinder head gasket (01-415).

Before installing cylinder head, always deburr the oil cross gallery and chamfer the edges, respectively.
