Mercedes-Benz

## service information

**REF. NO.** 61/4

**SUBJECT:** MODEL 124.036  
ENGINE COMPARTMENT PANELING

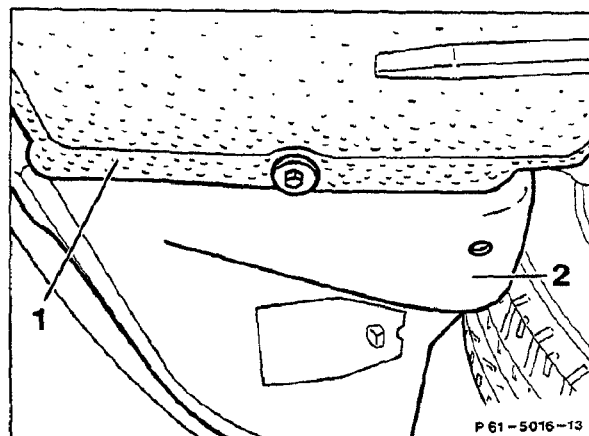
On some vehicles the lower engine compartment panel was incorrectly installed during production. The panel projects into the sides of the wheelhouse liners instead covering them from below.

- 1 Engine compartment panel
- 2 Wheelhouse liner

During the next maintenance requiring the removal of the lower engine compartment panel (1), make certain that you reinstall it in a such way that it will cover the left and right side wheelhouse liner (2) as illustrated. To do so, install the sheet metal clip nuts of the engine compartment panel on the wheelhouse liners.
